Obtaining Historic Timber Repair Viewpoints: Understanding The Contractor And Conservator Collaboration In Malaysian Building Conservation

Afzanizam Muhammad^{1*}, Norashikin Abdul Karim¹,
Azizul Azli Ahmad², Nordin Misnat³

Universiti Teknologi MARA, Perak Branch, 32610, Seri Iskandar, Perak, Malaysia

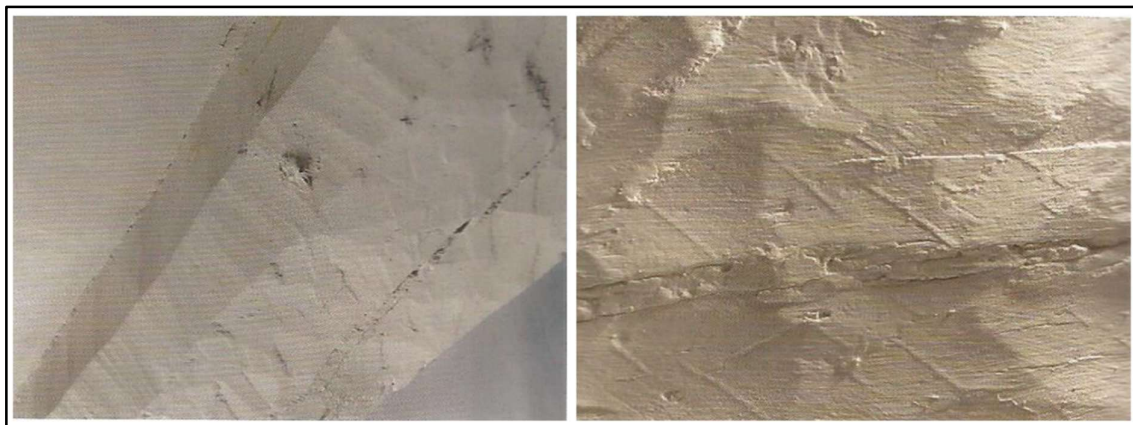
Figure 1: Cutting marks left on historic timber surface determine the past surfacing method uses adze or axe types. (Source: English Heritage, 2012).

Forsyth emphasised that one of the principles of restoring historic buildings is that the region's geology and topography determine its buildings' character and must be respected (Forsyth, 2008). The timber used on the heritage building described the surrounding forest vegetation when it was built (Rashid, 2007). For example, the Seri Menanti Palace in Negeri Sembilan, Malaysia, is among the heritage timber buildings. The palace columns measuring 62 feet tall with approximately one square foot of the section have become a question of how the chengal timber (*Neobalanucarpus Heemi*) was set up during the early 20th century is something wondered (Ibrahim, 2019). At least, at some point, the level of the old technology can be roughly figured out based on the existing construction and materials used. Therefore, the whole set of timber structures, their design, workmanship, and other details need to be considered a piece of historical information. The historical timber structure can be regarded as original preserved records in a physical form embodied in the heritage building that it's impossible to construct today. The historic timber structure of the building is not only physical evidence of the past but may also have played a role in history or is linked to specific events or periods in history. The history embodied within the building fabric was sometimes the only evidence of events and life in the past (Orbasli, 2008). There is a diversity of historic values embodied. That is why the remaining original materials are always prioritised in conservation works. The surface visual character of the historic timber surfaces contributes to the type of sawing tools used. For example, The work of a hand saw can be identified by the distinctive pattern of saw marks, while the use of a hand chisel can be recognised in the craftsmanship of wood joinery in heritage buildings (Source: English Heritage, 2012).

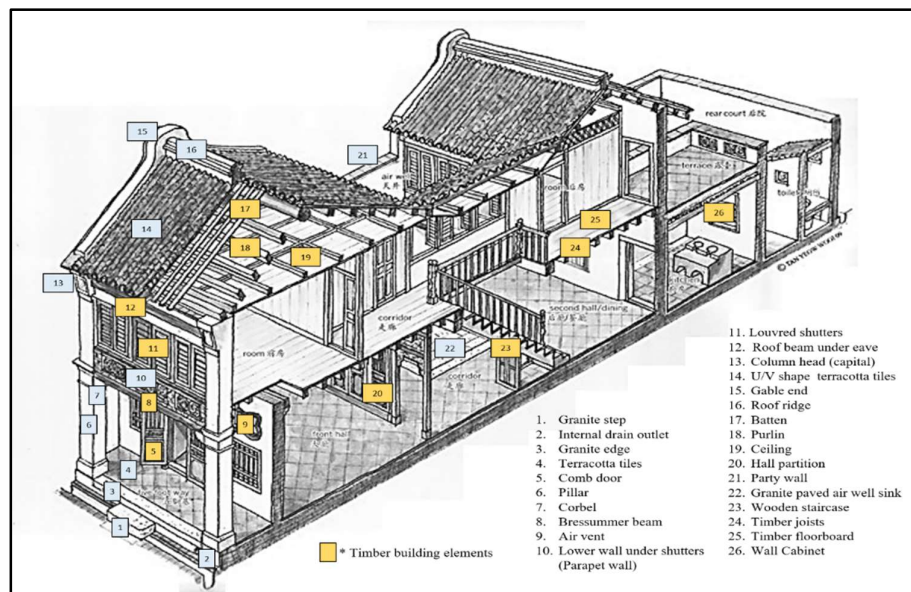
Figure 2: Typical Malaysian masonry shophouse construction that shows timber elements combination.
Adapted from Tan Yeow Wooi (2015)

In Malaysia, most of the buildings considered heritage buildings are traditional buildings and those built in the colonial period. Colonial buildings constructed during the British rule of 1800-1930 were mainly built of masonry except for their roof structure and timber floor (Ahmad, 1997; Yuan, 1987a). The rows of old shophouses in Malaysia constructed in that era similarly influenced construction technology (Figure 2). In addition, heritage buildings built around the British colonial era include royal buildings, public buildings, and commercials. Those buildings have timber as part of the construction material, especially for the roof structure, floors, doors and windows, including its decorative elements, even though the walls and columns are made from masonry (Yusof, 2014).

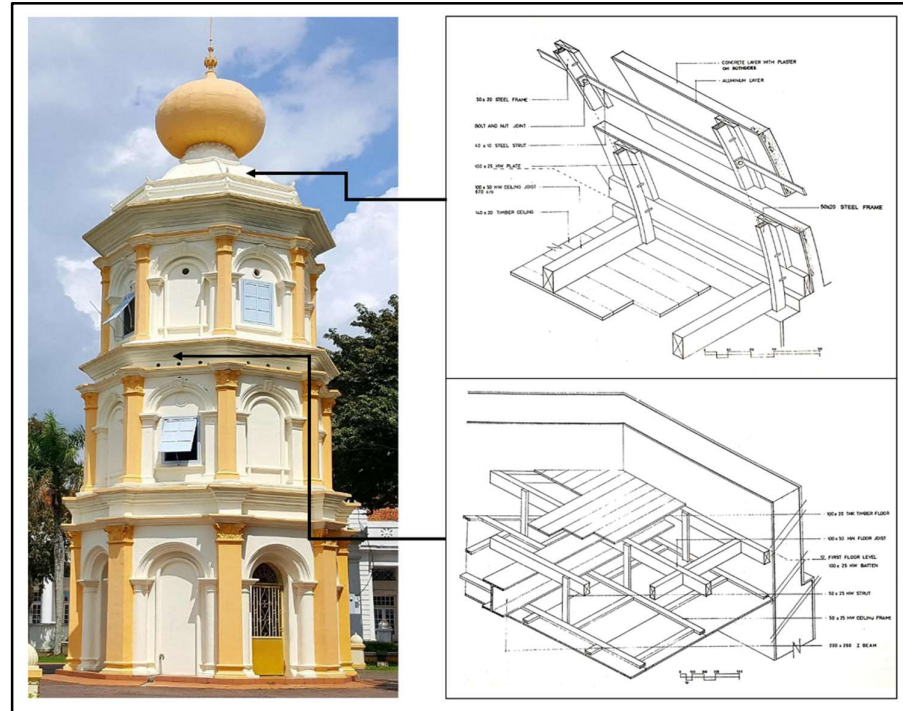
Figure 3: The construction technology of Balai Nobat in Alor Setar, Kedah (1917), during the British colonial era. Top-right: The dome is constructed of timber, concrete, and steel frame. Below-right: The floor system by various steel beams and timber on a masonry wall. Adapted from National Heritage Trust (1998).

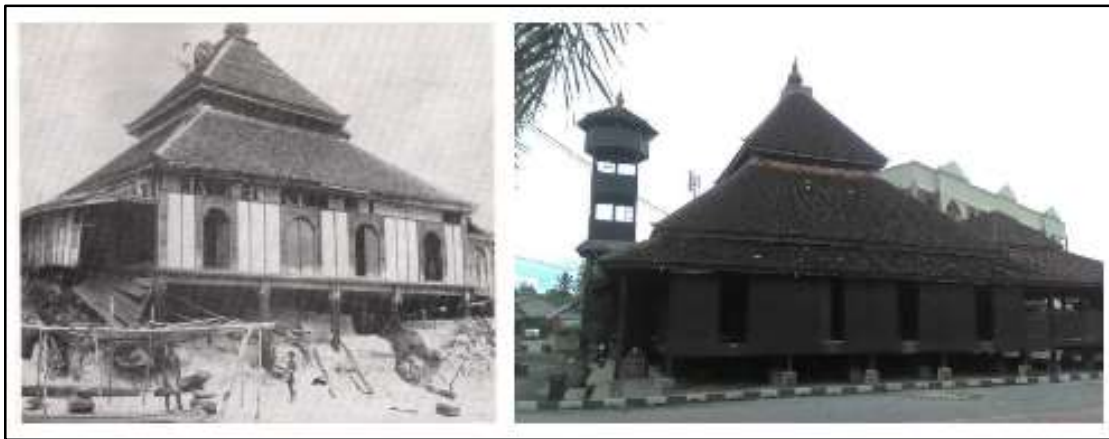
Figure 5: The Kampung Laut Mosque. Left; The mosque at its original site in 1966 after the river banks were eroded by heavy floods (Akib, 2003), and right; the mosque is well preserved at its new location in 2017.

In 1967, another conservation project of the traditional building was safeguarding Kampung Laut Mosque (*Masjid Kampung Laut*), which faced severe riverbank erosion (Md Ali, 2016). The Kampung Laut Mosque is the oldest timber mosque in Southeast Asia. It was built in the 17th century without iron nails, like other early Malay buildings constructed before the 20th century. This mosque has a similar roof design to the Demak Mosque in Java, Kono Mosque in Champa, Nad Tanjung Mosque and Wadi Hussein Mosque in Thailand (National Archive of Malaysia, 2017). The historical significance is related to the early Islamic influence in Peninsular Malaysia. The mosque was built by Islamic missionaries who travelled along Champa and Java with the help of local people. The original site of this mosque was in Kampung Laut, Tumpat, on the banks of the Kelantan River (Tumpat District Council, 2017). Until 1966, this mosque was used as the centre of Islamic worship by the residents of Kampung

Laut. However, this mosque was damaged by the flood that struck Kelantan at the end of 1966 and early 1967. The State Government has closed the mosque and built a new mosque in a safer place. In November 1967, the State Government renovated the Masjid Kampung Laut Mosque in collaboration with the Malaysian Historical Society of the National Museum. It was reassembled at its new site in Nilam Puri at its new original site (Tumpat District Council, 2017). From 2020 to 2021, relocating the mosque has been done again for conservation reasons.

The Kampung Laut Mosque and the Ampang Tinggi Palace are those saved by reallocating from their original location, made possible due to the timber construction technology. These are the unique methods practised in Malaysia. Unlike in Western conservation, building dismantling for relocation is practised in most Southeast Asian countries, such as Japan and Thailand, either for cultural or religious reasons (Orbasli, 2008). Dismantling of the timber building part effectively detects the decay in hidden places and facilitates refurbishment work on each building part (Brown, 2013). The ability to dismantle and reassemble the timber building parts enables more detailed work rather than in-situ repairs. In addition, reallocating the building will also save the building from the risk of damage due to site conditions.

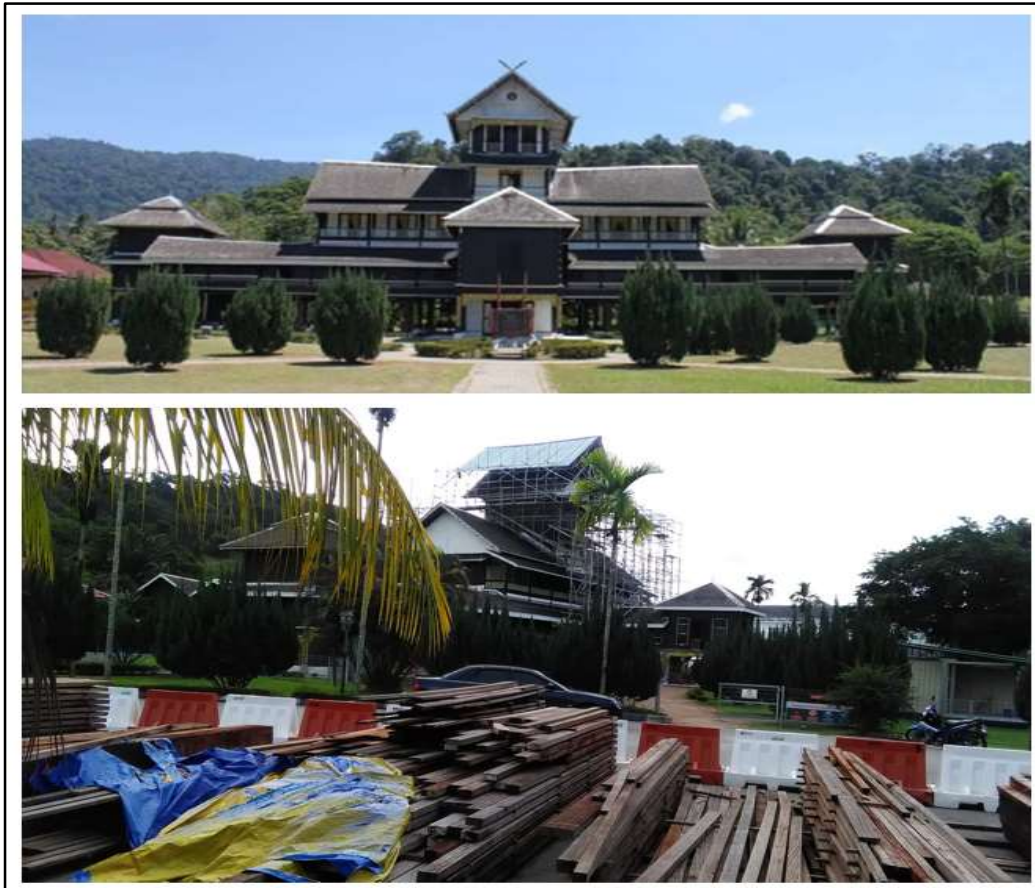
Figure 6: The Seri Menanti Palace. Top; The palace front view before the conservation work and below; the replacement timbers on-site view during the conservation work in 2017.

Malaysia's last Malay Timber palace was built at Seri Menanti, Negeri Sembilan. Seri Menanti Palace construction began in 1902 and was completed in 1908. It was the official residence of the Yang DI-Pertuan Besar, Tuanku Muhammad, until 1931 (Sheppard, 1986). The building has been through several repairs until the latest repair of its decayed main pillars in 2017 (Ibrahim, 2019). The repair involved the work of cutting its main columns that had rotted and jointed with new timber. The rotten parts stem from rainwater from roof leaks and seeped into the columns over time. The interior condition slows down the evaporation, which catalyses the rot. In 1992, DYMM Tuanku Jaafar Ibni Almarhum Tuanku Abdul Rahman instructed the palace to be designated as 'The Royal Museum' under the management of the State Museum Administration. Seri Menanti Palace has changed its function from a residence to a place to exhibit the collections of the royal family. Each room has been filled with displays without changing the original form of the palace to show its original space function (Shahminan *et al.*, 2019). In 2017, the palace was identified as unsafe, and immediate action to safeguard

the palace started until its completion in early 2019. However, further repair work is in the pipeline, including landscaping work (Rahman, 2019).

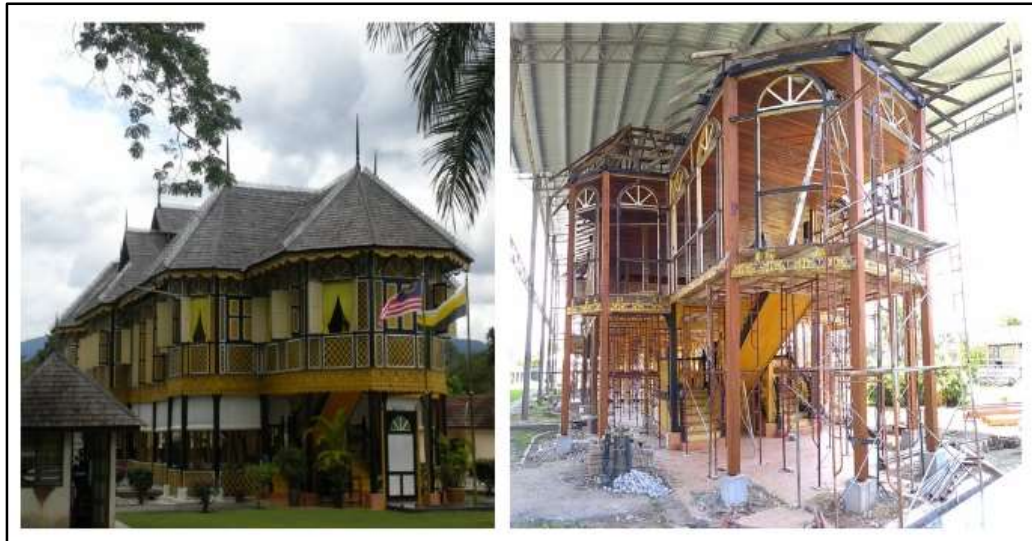
Figure 7: The Kenangan Palace, Kuala Kangsar, Perak. Left; the Palace before conservation, and right; during the conservation work in 2017. (Source: Author, 2017)

In Kuala Kangsar, Perak, the Kenangan Palace, built in 1923, underwent major conservation in 2017. However, it was built as a temporary palace while the actual palace was still constructed during that time. Later, the Istana Kenangan became the royal family's residence (Muhammad *et al.*, 2012). It retains the significant Perak royal identity with the coloured bamboo weaving walls. The 2017 conservation work involved replacing damaged parts of the building due to roof leaks and raised ground moisture. A few modifications have been made between the columns and stumps to prevent the same moisture problems from recurring. The traditional timber palace was originally able to be dismantled part by part. However, the repairs done in the past with steel-reinforced timber members to support the main structure from damages due to the ground movement had changed this dismantlable timber building to a permanent one.
